# Manhole Inspection Summary

Manhole # S43SS\_030MH

Insp Date: **2/27/07 11:05 AM**

**Location** Address: **2636 ROBB ST**

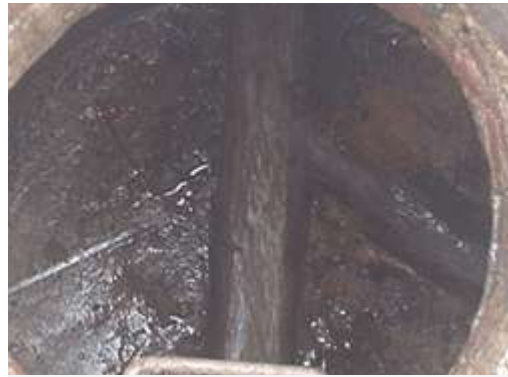
Top View

Bench debris.

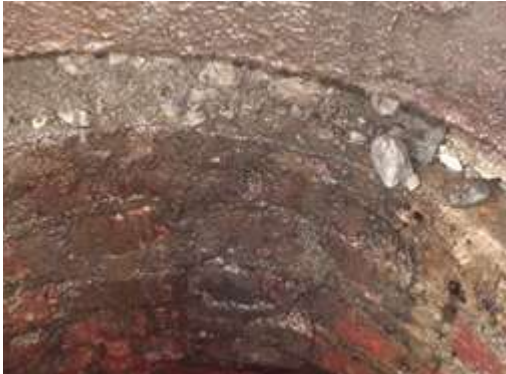
Defect

**Frame** Offset: **3** (in.) Condition: ☐ Sound ☐ Cracked ☒ **Leaks**

Condition: ☐ Sound ☐ Cracked ☐ Root Intrusion ☐ Loose Brick ☒ **Deteriorated**

Infiltration: ☐ None ☒ **Joint** ☐ Cracks ☐ Mortar ☐ Roots ☒ **Wall**

Frame leaks. Frame offset. Adjustment deterioration and infiltration.

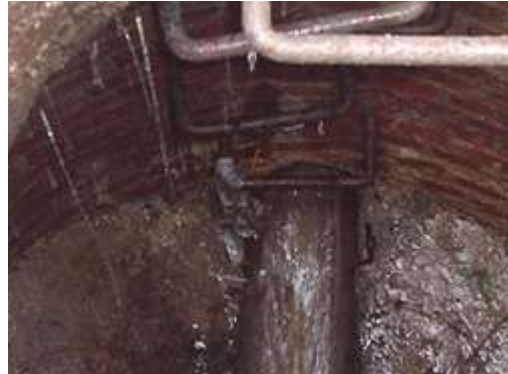
Defect

Infiltration: ☐ None ☐ Joint ☐ Cracks ☐ Mortar ☐ Roots ☒ **Wall**

**Steps** Count: **5** Missing: **0** ☒ **Corroded**

**Surcharge** ☒ **Evidence Of Surcharge** Depth: **3** (ft.) ☐ Active Surcharge Present

Barrel infiltration. Corroded steps. Evidence of surcharge - Bench debris.

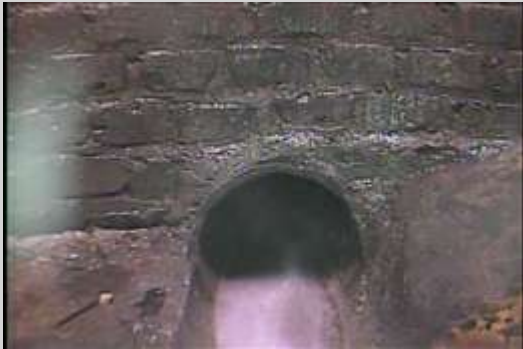
### 8 in. Circular Gravity Sewer Pipe Out @ 12 O'Clock

Infiltration: **None** Pipe Seal Cond: **Unknown**

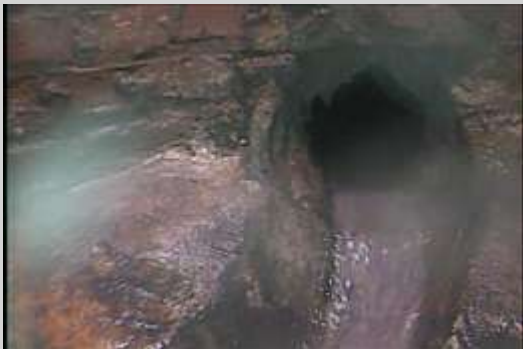
### 8 in. Circular Gravity Sewer Pipe In @ 3 O'Clock

Infiltration: **Evidence** Pipe Seal Cond: **Broken**

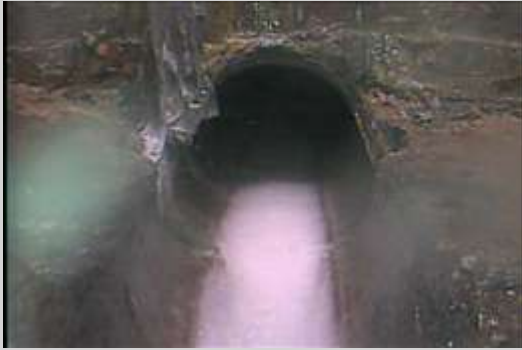
Pipe In @ 6 O'Clock

Infiltration: **Evidence** Pipe Seal Cond: **Cracked**
